**Flood Control Project Maintenance
Levee Inspections**

Fall 2018 Levee Maintenance Deficiency Summary Report

Sacramento River Basin

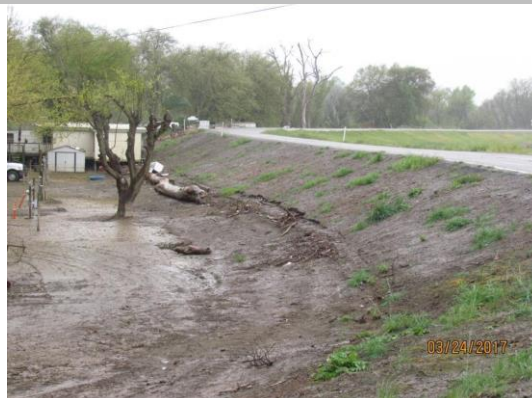
Photo 1 of 1 : FA_2018_ST0003_264_130_20180905_00030.jpg

LM Start	0.11	Rating **	M	Issue No.	130
LM End	0.14	Issue Type +	Ma	Location *	WS
Category	Earthen Levee			GPS Latitude/Longitude	
				Start	End
Item	Slope Stability			39.195163 °	39.195038 °
				-121.936815 °	-121.937435 °
DWR ID	DWR_ST0003_01_s_2017_130				
Comment Code					
S1 : Repair slope instability.					
Inspector Comment					
Repair the erosion along the waterside slope.

View of the erosion along the waterside slope.

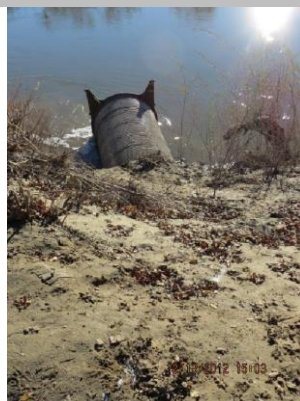
Photo 2 of 3 : UCIP_FA_2018_51650_46960.jpg

Item	DWR UCIP LMA Responsibility			39.197028 °	39.197028 °	
				-121.943597 °	-121.943597 °	
DWR ID	17307					
Comment Code						
Inspector Comment						
FS_ID:51650 DS_ID:17307 EP_NO: 9534 Repair Type: No Action Needed Crossing Status: Found UCIP Comments: 10/27/2017 This structure is inspected annually under the Structure and Channel Summer Inspection (part of the Levee Inspection Program) conducted by the DWR Flood Project Integrity and Inspection Branch (FPIIB). (DWR UCIP - O. Magana) 4/24/2017 Both sides of crossing were underwater during site visit. Will need to revisit after water levels drop. (DWR Sutter Yard-AFreitag)11/7/2016 Crossing appears to be in good condition. (DWR Sutter Yard- AFreitag)6/6/2016 Crossing appears to be in good condition.4/6/2015 Good Condition. No issues. Semi circle CMP half riser in inlet structure on LS. Inlet opeing has no trash rack, this may cause safety issue.6/30/2014 Same as last inspection.12/30/2013 Same as last inspection.7/29/2013 Same as last inspection. FIELD_STRUCT_DESC: [Butte Slough Drainage Structure] 78-inch drainage pipe of an unknown material through the levee, 3 feet below the crown. Flap gate on the waterside (WS). Corrugated metal pipe (CMP) half riser (in a semi-circle configuration) in the inlet structure on the landside (LS). (78-inch pipe [HLM 0.44] authorized under Automatic Board Order (ABO) issued as Permit No. 9534, 1974 - Caleta). [Additional Reference(s): DWR Levee Log, 2002. USACE Sacramento O&M Manual 136, March 1960 (HLM 0.44)]. FS Date: 4/26/2017 9:46:51 AM

Waterside view: water flowing from CMP sewer pipe

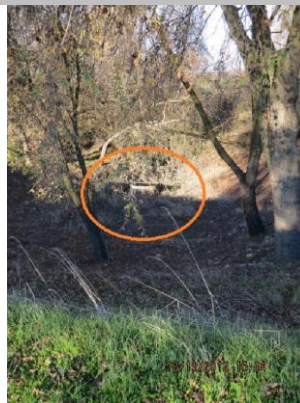
Photo 3 of 3 : UCIP_FA_2018_51650_46961.jpg

Landside view: overview

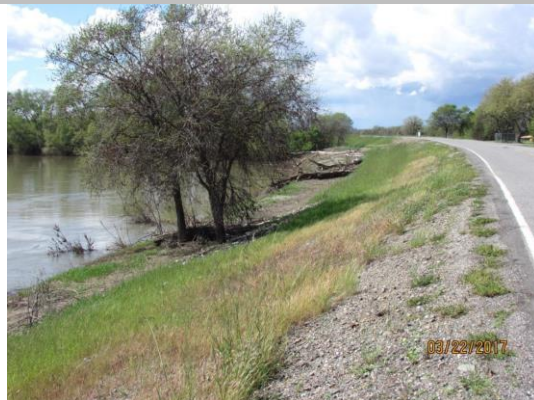
Photo 1 of 1 : FA_2018_ST0003_264_9_20180905_00007.jpg

LM Start	0.54	Rating **	M	Issue No.	9
LM End	0.68	Issue Type +	Ma	Location *	WS
Category	Earthen Levee			GPS Latitude/Longitude	
				Start	End
Item	Encroachments			39.197267°	39.198178°
				-121.944232°	-121.946412°
DWR ID	DWR_ST0003_01_s_2017_9				
Comment Code					
DE : Debris					
Inspector Comment					
Remove the debris from the waterside slope.

View of the debris along the waterside slope.

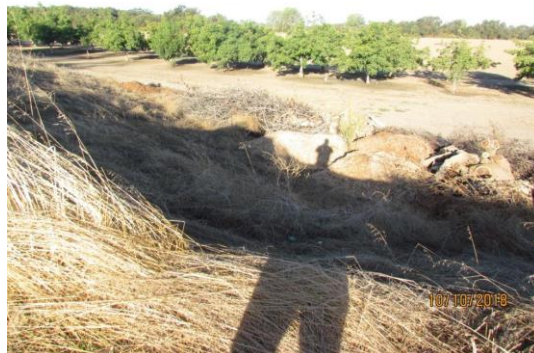
Photo 1 of 1 : FA_2018_ST0003_264_93_20181105_00185.jpg

LM Start	0.74	Rating **	M	Issue No.	93
LM End	0.74	Issue Type +	En	Location *	LS
Category	Earthen Levee			GPS Latitude/Longitude	
				Start	End
Item	Encroachments			39.198310 °	39.198310 °
				-121.947463 °	-121.947463 °
DWR ID	DWR_ST0003_01_f _2018_93				
Comment Code					
DE : Debris					
Inspector Comment					
Remove the prunings the landside slope and toe.

View of the prunings along the landside slope and toe.

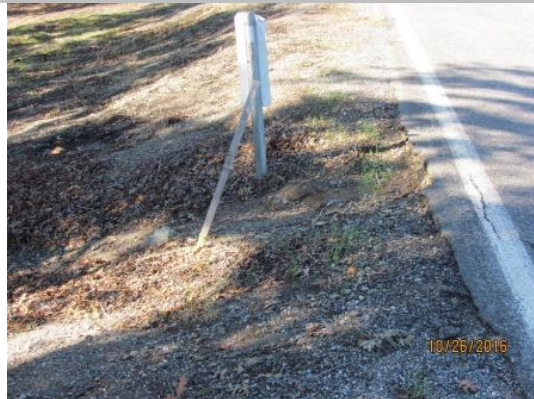
Photo 1 of 1 : FA_2018_ST0003_264_80_20180905_00018.jpg

LM Start	1.17	Rating **	M	Issue No.	80
LM End	1.17	Issue Type +	Ma	Location *	WS
Category	Earthen Levee			GPS Latitude/Longitude	
				Start	End
Item	Slope Stability			39.194126 °	39.194126 °
				-121.953345 °	-121.953345 °
DWR ID	DWR_ST0003_01_f_2016_80				
Comment Code					
S1 : Repair slope instability.					
Inspector Comment

View of the slope instability along the waterside slope.

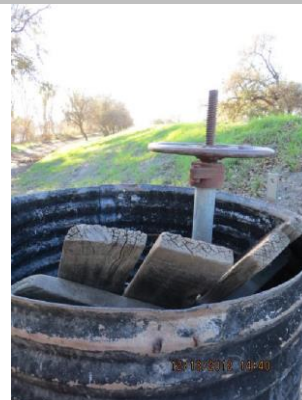
Photo 2 of 3 : UCIP_FA_2018_53399_46981.jpg

FS_ID:53399
DS_ID:17319
EP_NO: 9527
Repair Type: Urgent
Crossing Status: Found
UCIP Comments: 8/30/2018 WS vegetation completely overgrown towards walkway and pump so could not inspect. WS pipe end is nearly completely covered in debris, pipe cap appears either open or broken, LS erosion still present, and pipe end completely covered in debris so crossing remains Urgent (D. Sanoski - DWR UCIP).4/24/2017 LS slope damage is still present. No repairs have been made to this crossing yet. (DWR Sutter Yard- AFreitag)11/7/2016 No LS repairs have been made yet. (DWR Sutter Yard- AFreitag)6/6/2016 New flow meter installed on WS. Walkway to access the pump is overgrown with vegetation and not accessible. (DWR Sutter Yard - afreitag) 4/5/2016 Caved-in slope on landside (LS) not yet repaired. Leaky pipe marker gone. Per Bob Duffey (DWR FPIIB inspector), pipe will be replaced by owner next year. If not, will go to CVFPB enforcement. (DWR UCIP - kfazel)4/6/2015 Pipe leaks during times of High water. Slope damage still present. Needs a more detailed inspection to find the leak. (DWR Sutter Yard - afreitag)6/30/2014 Same as last inspection. (DWR Sutter Yard - afreitag)12/30/2013 Same as last inspection. (DWR Sutter Yard - afreitag)7/29/2013 Pipe does not appear to be abandoned. On the WS it appears that a smaller pipe was sleeved into the 18in. Pipe and then the difference capped and welded. Pump was not running at time of inspection but LS ditch near outlet was wet. LS slope damage and leaky pipe marker are still present. (DWR Sutter Yard - afreitag)12/13/2012 Abandoned and plugged/capped steel pipe on WS berm. DWR leaky pipe marker on LS (12-3). Slope failure on LS. Needs capping of LS steel pipe after detailed investigation. (DWR UCIP - pamatya)

Waterside view: CMP riser with slide gate

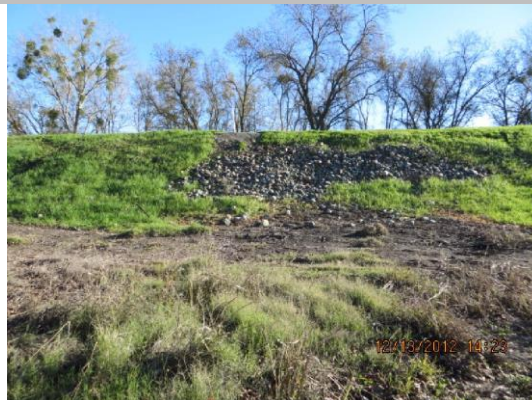
Photo 3 of 3 : UCIP_FA_2018_53400_46990.jpg

UCIP Comments: 8/30/2018 WS vegetation too thick to clearly inspect WS pipe so assume same condition as last inspections so crossing remains Urgent due to pipe integrity. WS levee slope looks good. No signs of levee threat to the road crown. LS headwall looks in good condition (D. Sanoski - DWR UCIP).4/24/2017 WS was underwater during the site visit but I do not believe that any repairs have been made to this crossing yet. (DWR Sutter Yard- AFreitag)11/7/2016 No repairs have been made here yet. (DWR Sutter Yard- AFreitag)6/17/2016 River levels were down and the WS pipe end was exposed. WS end is completely rotten and damaged and flap gate has fallen off the end of the pipe (see pics). Pipe needs to be replaced or repaired. (DWR Sutter Yard - afreitag)4/5/2016 Erosion on WS slope still present. Pipe still fully submerged on WS and discharging into river during site visit. (DWR UCIP - kfazel)4/6/2015 Pipe leaks during high water. DWR employee said he suspects that the flap gate has rotted and fallen off WS end of pipe. Could not locate WS end of pipe to confirm. Water was flowing through this drain during field survey. (DWR Sutter Yard - afreitag)6/30/2014 Same as last inspection. (DWR Sutter Yard - afreitag)12/30/2013 Same as last inspection. (DWR Sutter Yard - afreitag)7/29/2013 Same as last inspection. (DWR Sutter Yard - afreitag) 12/13/2012 Water was flowing through this drain during field survey. (DWR UCIP - pamatya)

Landside view: overview of levee slope

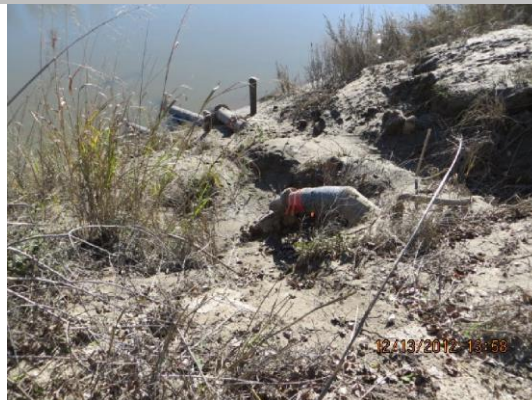
Photo 1 of 3 : UCIP_FA_2018_51656_46998.jpg

Comment Code					
Inspector Comment					
FS_ID:51656 DS_ID:17322 EP_NO: 9258 Repair Type: Non-Urgent Crossing Status: Found UCIP Comments: 4/24/2017 WS riser was still full of soil. Open 10" pipe on the WS bank was underwater during time of site visit. (DWR Sutter Yard- A Freitag)11/7/2016 WS riser still full of soil. No pump present and 10" pipe left opened on the WS. (DWR Sutter Yard- A Freitag)6/17/2016 Same as last inspection. 4/6/2015 CMP riser filled with silt/soil on WS. No other issues present.6/30/2014 Same as last inspection.12/30/2013 Same as last inspection.7/29/2013 Same as last inspection. FIELD_STRUCT_DESC: 10-inch asphalt coated steel irrigation pipe through the levee, 3.7 feet below the crown. Pump installed on the waterside (WS). (Permit No. 9258, 1974 - Harada). [Additional Reference(s): DWR Levee Log, 2002]. FS Date: 4/26/2017 10:15:33 AM

Waterside view: overview

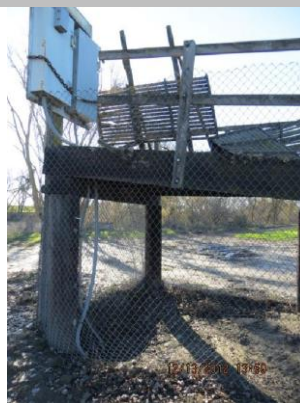
Photo 3 of 3 : UCIP_FA_2018_52947_47002.jpg

Waterside view: abandoned pump station close-up.

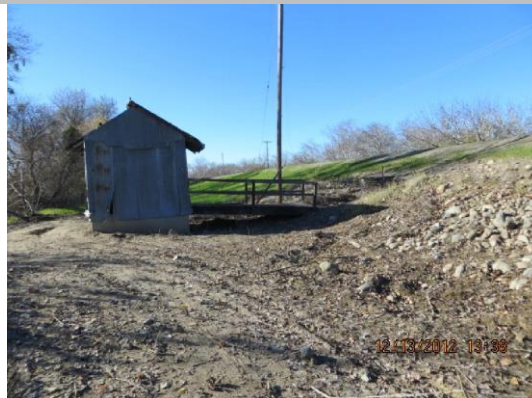
Photo 1 of 3 : UCIP_FA_2018_51658_47013.jpg

Waterside view: overview

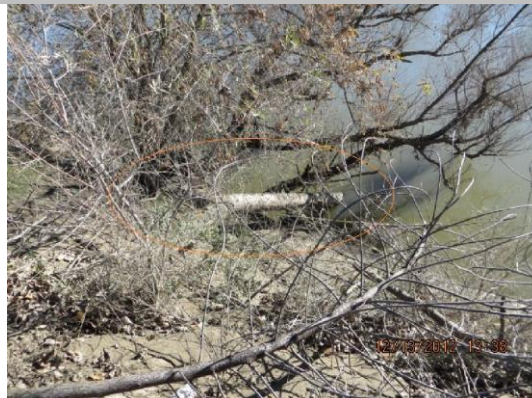
Photo 2 of 3 : UCIP_FA_2018_51658_47011.jpg

Waterside view: overview of pipe

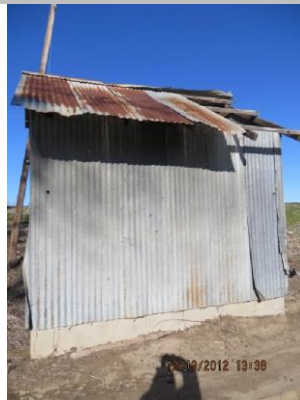
Photo 3 of 3 : UCIP_FA_2018_51658_47012.jpg

Item	DWR UCIP Field Study		39.187717°	39.187717°								
			-121.967712°	-121.967712°								
DWR ID	17305											
Comment Code												
Inspector Comment												
FS_ID:51658 DS_ID:17305 EP_NO: 9541 Repair Type: Non-Urgent Crossing Status: Found UCIP Comments: 4/24/2017 Abandoned and needs to be done so properly. (DWR Sutter Yard- A Freitag) 11/7/2016 Abandoned. (DWR Sutter Yard- A Freitag) 6/6/2016 Abandoned crossing. Should be properly abandoned. 4/6/2015 Same as last inspection. CMP standpipe with gate valve. Abandoned pump house. Pipe discharges into open ditch at landward toe- not found. 6/30/2014 Same as last inspection. 12/30/2013 Same as last inspection. 7/29/2013 Same as last inspection. FIELD_STRUCT_DESC: *ABANDONED* 24-inch irrigation pipe of an unknown material through the levee, 13.5 feet below the crown. Pump in a metal house on the WS (waterside) berm. Slide gate in a corrugated metal pipe riser on the WS slope. Service pole and guy wire anchor on the WS slope. (Automatic Board Order (ABO) issued as Permit No. 9541, 1974 - Wilbur, McGowan, Zinke). [Additional Reference(s): DWR Levee Logs, 2002. USACE Sacramento O&M Manual 136, March 1960 (HLM 2.01)]. FS Date: 4/26/2017 10:40:26 AM

Waterside view: abandoned pump house

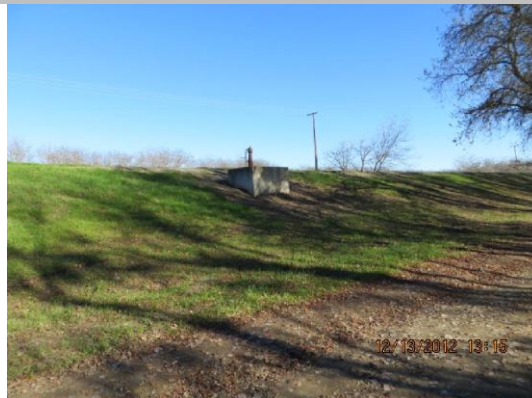
Photo 1 of 3 : UCIP_FA_2018_51660_47027.jpg

Waterside view: overview- concrete surg tank

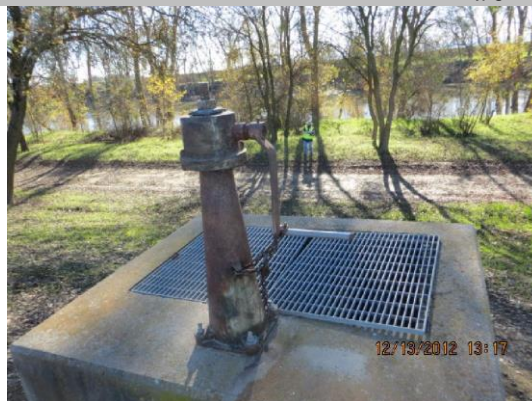
Photo 2 of 3 : UCIP_FA_2018_51660_47026.jpg

Waterside view: overview- concrete surg tank

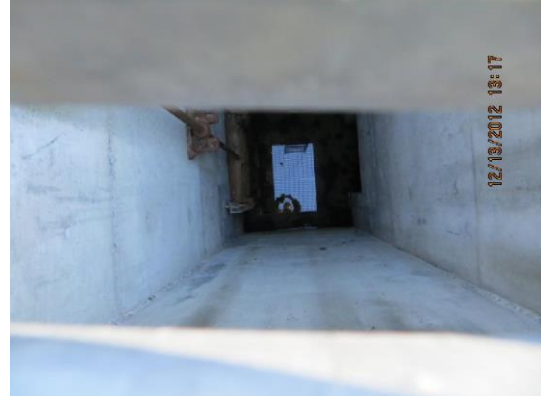
Photo 3 of 3 : UCIP_FA_2018_51660_47025.jpg

Comment Code					
Inspector Comment					
FS_ID:51660 DS_ID:17309 EP_NO: 9541 Repair Type: Non-Urgent Crossing Status: Found UCIP Comments: 4/24/2017 Still no sign of WS pipe end or flapgate. LS appears to be in good condition. (DWR Sutter Yard- AFreitag) 11/7/2016 LS culvert measured to be 30"wide X 30"tall. WS end is not vidible so could not be measured. (DWR Sutter Yard- AFreitag)6/6/2016 Cannot locate the WS headwall/flapgate. Appears to have been silted over.4/6/2015 Same as last inspection. Concrete surg box on WS. Flap gate in concrete "U" headwall at the waterward end- not found.6/30/2014 Same as last inspection.12/30/2013 Same as last inspection.7/29/2013 Same as last inspection. FIELD_STRUCT_DESC: 30-inch reinforced concrete box drainage culvert through the levee, 14.3 feet below the crown. 30-inch corrugated metal pipe connects concrete culvert from slide gate out to flap gate on the waterside (WS) end. Slide gate in a concrete riser on the waterside (WS) slope. (30-inch pipe [HLM 2.49] authorized under Automatic Board Order (ABO) issued as Permit No. 9541, 1974 - Wilbur, McGowan, Zinke). [Additional Reference(s): DWR Levee Logs, 2002. USACE Sacramento O&M Manual 136, March 1960 (HLM 2.49)]. FS Date: 4/26/2017 10:46:22 AM

Waterside view: slide gate inside concrete surg tank

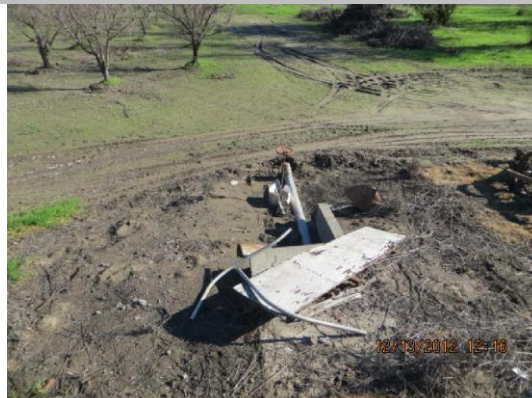
Photo 2 of 3 : UCIP_FA_2018_53401_47046.jpg

UCIP Comments: 8/30/2018 Same as last inspection. Recommend internal pipe inspection to verify pipe integrity and levee integrity so crossing remains Urgent (D. Sanoski - DWR UCIP).4/24/2017 Pipe leaked during the Jan/Feb 2017 high water event. Gap between the top of the WS headwall and concrete plug plus the WS airvents going underwater are the cause of the uncontrolled water flows. (DWR Sutter Yard- AFreitag)11/7/2016 Nothing has changed with this crossing since the last inspection. The gap between the top of the WS headwall and concrete plug could be a problem with water flow during high water times. (DWR Sutter Yard- AFreitag)6/6/2016 One of the pipes appear to be leaking inside of the concrete culvert. From the WS headwall water can be heard flowing inside of the levee behind the concrete plug. The concrete plug also appears to leak as water current can be seen flowing around it. There is also a 1" gap at the top of the plug and the old WS headwall that will allow high water to flow through uncontrolled. (DWR Sutter Yard - afreitag)4/6/2015 6-inch and 18-inch pipes still present in crossing and WS end still plugged with concrete. It seems that the system was originally designed for drainage but later converted into an irrigation system. 6-inch GI pipe and 18-inch PVC pipes inserted into culvert from LS (not plugged). WS opening is plugged with concrete. Probably pump is located 350 ft from levee as seen from Google Earth Map. (DWR Sutter Yard - afreitag)6/30/2014 Same as last inspection. (DWR Sutter Yard - afreitag)12/30/2013 Same as last inspection. (DWR Sutter Yard - afreitag)7/29/2013 Same as last inspection. (DWR Sutter Yard - afreitag) FIELD_STRUCT_DESC: 30-inch by 36-inch reinforced concrete box drainage and irrigation culvert through the levee, invert 13.6 feet below the crown. Gates with 2-inch flashboards on the waterside (WS) end. 6-inch and 18-inch polyvinyl chloride (PVC) pipes through the culvert on the landside (LS). Culvert designed for drainage but now used for irrigation. (Automatic Board Order (ABO) issued as Permit No. 9539, 1974 - Locvich). [Additional Reference(s): DWR Levee Log, 2002. USACE Sacramento O&M Manual 136, March 1960 (HLM 3.33)]. FS Date: 8/30/2018 10:18:00 AM

Landside view: overview- concrete culvert and pipes

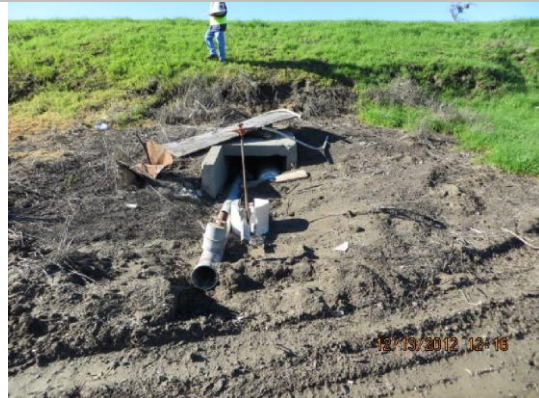
Photo 3 of 3 : UCIP_FA_2018_53401_47047.jpg

Landside view: overview of concrete culvert and pipes

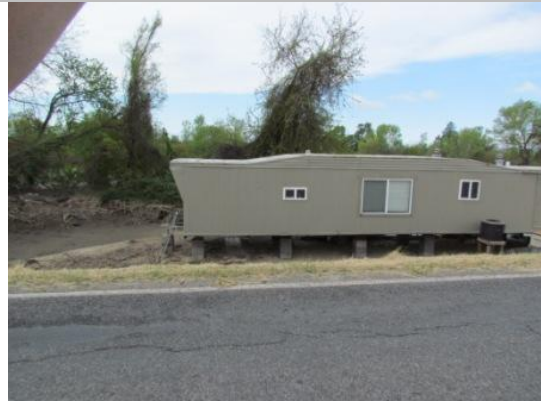
Photo 1 of 1 : FA_2018_ST0003_264_11_20180905_00008.jpg

LM Start	3.54	Rating **	M	Issue No.	11
LM End	3.81	Issue Type +	En	Location *	WS
Category	Earthen Levee			GPS Latitude/Longitude	
				Start	End
Item	Encroachments			39.200007 °	39.203634 °
				-121.985257 °	-121.982977 °
DWR ID	DWR_ST0003_01_f_2016_11				
Comment Code					
BU : Building					
Inspector Comment

View of a trailer next to the waterside toe.

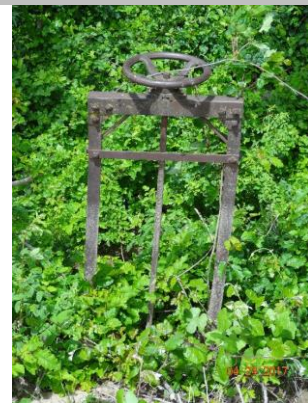
Photo 1 of 2 : UCIP_FA_2018_51666_77004.jpg

Comment Code					
Inspector Comment					
FS_ID:51666 DS_ID:17313 EP_NO: N/A Repair Type: Non-Urgent Crossing Status: Found UCIP Comments: 4/24/2017 Slide gate structure found on WS about 10ft from levee toe. Vegetation was too thick to see if there were any more appurtances associated with this crossing visible on the WS. Nothing was visible on the LS. House located above pipe alignment at LS levee toe. Crossing appears abandoned and should be done so properly. (DWR Sutter Yard- AFreitag)11/7/2016 Unable to locate. (DWR Sutter Yard- AFreitag)6/6/2016 Unable to locate.4/6/2015 Unable to locate.6/30/2014 Unable to locate.12/30/2013 Unable to locate7/29/2013 Same as last inspection. Unable to locate. FIELD_STRUCT_DESC: *ABANDONED* 18-inch corrugated metal drainage pipe through the levee, 15 feet below the crown. Slide gate on the waterside (WS) end. [Additional Reference(s): DWR Levee Log, 2002. USACE Sacramento O&M Manual 136, March 1960 (HLM 3.6)]. FS Date: 4/26/2017 12:11:41 PM

Slide gate structure found on WS

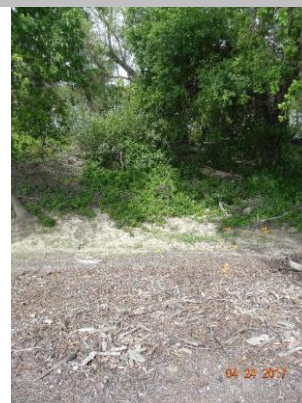
Photo 2 of 2 : UCIP_FA_2018_51666_77005.jpg

View of WS from levee shoulder

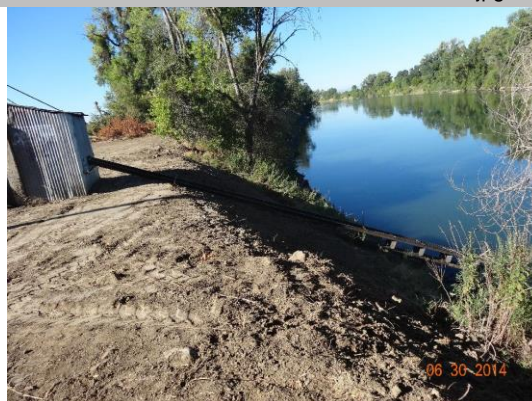
Photo 1 of 3 : UCIP_FA_2018_51671_71480.jpg

WS river bank

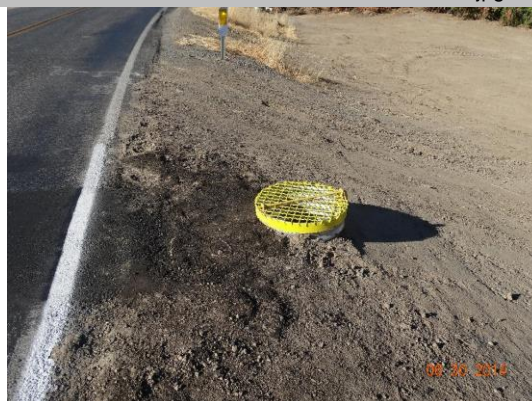
Photo 2 of 3 : UCIP_FA_2018_51671_71479.jpg

WS standpipe with shut off valve inside

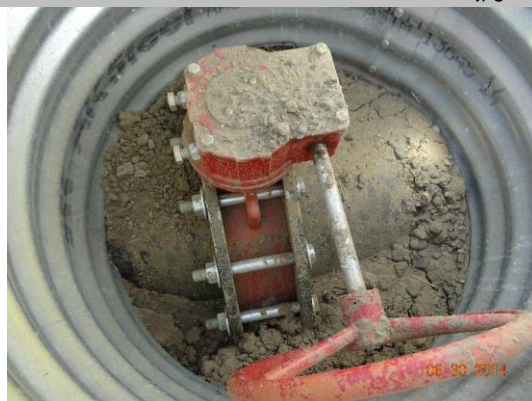
Photo 3 of 3 : UCIP_FA_2018_51671_71478.jpg

WS shut off valve

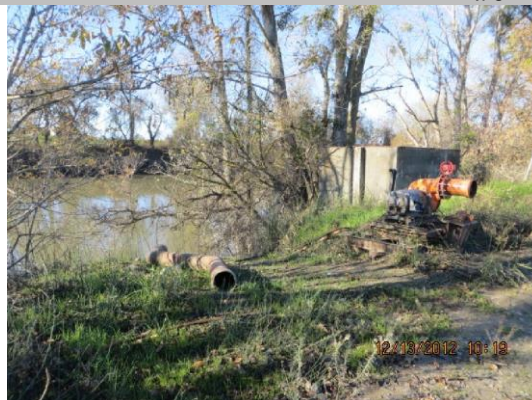
Photo 2 of 3 : UCIP_FA_2018_52952_47067.jpg

UCIP Comments: 8/30/2018 Same as last inspection, with no signs of any improvements made to pipe or pump. Vegetation obstructed full inspection at water level, but the levee looks in very good condition with no signs of threat. Downgrading to Non-Urgent from Urgent due to the good condition of the levee (D. Sanoski - DWR UCIP).4/24/2017 WS was mostly underwater during site visit. Not sure if the 10" pipe was still opened or capped on the WS end but no water appeared to be free flowing through the levee. No sign of orange pump. (DWR Sutter Yard-AFreitag)11/7/2016 Orange pump was not present at this inspection. 10" pipe penetration left opened on WS end. (DWR Sutter Yard-AFreitag)6/17/2016 Orange pump motor was lowered down the WS berm to water level and was pumping water through the pipe to the LS outlet. What is pictured in (photo#17 UCIP_Photos_No.75150) as "pipe debris" is the pipe section that is used to connect the orange pump to the open 10" pipe that penetrates the levee. In the same photo the "possible penetration" is the flexible suction line for the pump. (DWR Sutter Yard - aFreitag)4/4/2016 Flow meter installed on LS indicates this pipe is used seasonally and not abandoned. Pipe open on WS (see photo). No cover on old siphon breaker. Slight sloughing of LS slope. (DWR UCIP - kfazel)4/6/2015 Pump disconnected and pulled up to WS toe. Not Sure if leaky valve has ever been fixed. (DWR Sutter Yard - aFreitag)6/30/2014 Same as last inspection. (DWR Sutter Yard - aFreitag)12/30/2013 Same as last inspection. (DWR Sutter Yard - aFreitag)7/29/2013 Not an abandoned crossing. Pump is connected to WS pipe end at water level and is pumping water to LS and then goes underground to an irrigation ditch about 100yds. upstream. Pump and pipes are disconnected and pulled up to WS toe for high water season. Leaky valve on LS shoulder does not appear to have been fixed. (DWR Sutter Yard - aFreitag)12/12/2012 Motor and pump on berm. Appears an abandoned crossing. Leaky valve on LS slope. Pipe removed and laying on berm. No electric connection to the pump. (DWR UCIP - pamatya)

Waterside view: overview of pump and abandoned pipe

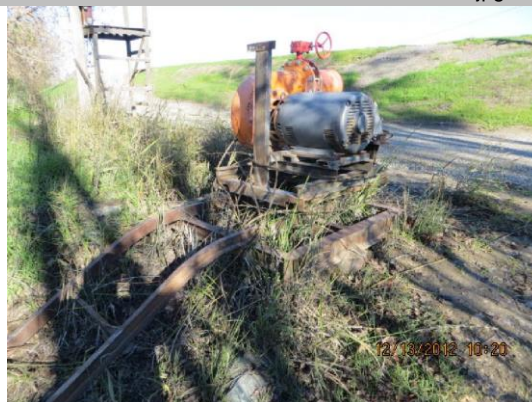
Photo 3 of 3 : UCIP_FA_2018_52952_47066.jpg

WS view: pump motor on the berm (found at water level in 2016)

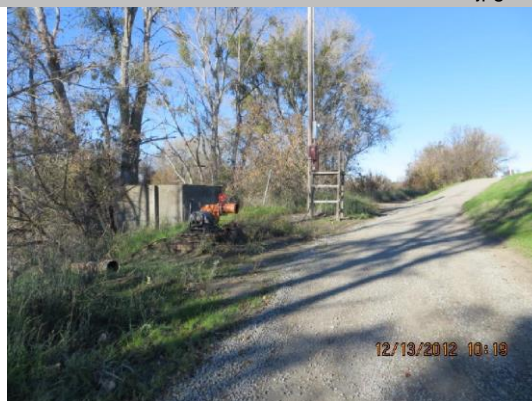
Photo 2 of 3 : UCIP_FA_2018_52953_47079.jpg

Comment Code						
Inspector Comment						
FS_ID:52953 DS_ID:17326 EP_NO: 9501 Repair Type: Non-Urgent Crossing Status: Found UCIP Comments: 8/30/2018 Same as last inspection. Needs to be abandoned properly; downgrading to Non-Urgent from Urgent (D. Sanoski - DWR UCIP).4/24/2017 Abandoned and needs to be done properly. (DWR Sutter Yard- AFreitag)11/7/2016 Abandoned and should be done so properly. (DWR Sutter Yard- AFreitag)6/17/2016 Abanoned pipe. photo comments updated. (DWR Sutter Yard - afreitag)4/4/2016 Open on WS. Needs proper abandonment. Contact owner to determine status of crossing. (DWR UCIP - kfazel)4/6/2015 Same as last inspection. (DWR Sutter Yard - afreitag)6/30/2014 Same as last inspection. (DWR Sutter Yard - afreitag)12/30/2013 Same as last inspection. (DWR Sutter Yard - afreitag)7/29/2013 Same as last inspection. (DWR Sutter Yard - afreitag)12/12/2012 Need to be properly abandoned. Transverse cracks on levee road.Also found a concrete outlet on LS. It is not clear whether this passes through the levee. (DWR UCIP - pamatya) FIELD_STRUCT_DESC: *ABANDONED* 16-inch steel irrigation pipe, 13.9 feet below the crown. Gate valve and pump in pump house on the waterside (WS) berm. 2-3 inch electrical conduit penetrates levee alongside pipe. Flap gate and concrete distribution box on the landside (LS). (Automatic Board Order (ABO) issued as Permit No. 9501, 1974 - Mayfair Farms, abandoned under Permit No. 9501-A, 1978 - MayFair Packing, Inc.). [Additional Reference(s): DWR Levee Log, 2002. USACE Sacramento O&M Manual 136, March 1960 (HLM 4.37)] FS Date: 8/30/2018 11:27:41 AM

Waterside view: overview

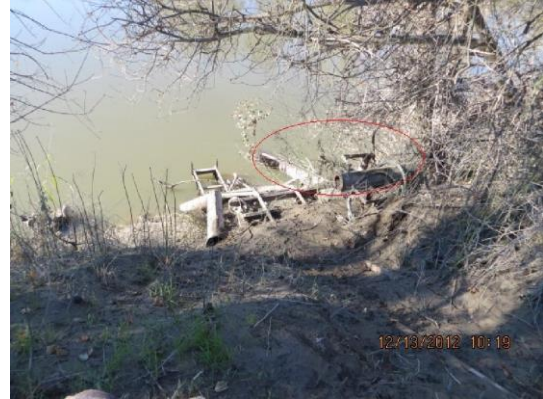
Photo 3 of 3 : UCIP_FA_2018_52953_47078.jpg

Comment Code						
Inspector Comment						
FS_ID:52953 DS_ID:17326 EP_NO: 9501 Repair Type: Non-Urgent Crossing Status: Found UCIP Comments: 8/30/2018 Same as last inspection. Needs to be abandoned properly; downgrading to Non-Urgent from Urgent (D. Sanoski - DWR UCIP).4/24/2017 Abandoned and needs to be done properly. (DWR Sutter Yard- AFreitag)11/7/2016 Abandoned and should be done so properly. (DWR Sutter Yard- AFreitag)6/17/2016 Abanoned pipe. photo comments updated. (DWR Sutter Yard - afreitag)4/4/2016 Open on WS. Needs proper abandonment. Contact owner to determine status of crossing. (DWR UCIP - kfazel)4/6/2015 Same as last inspection. (DWR Sutter Yard - afreitag)6/30/2014 Same as last inspection. (DWR Sutter Yard - afreitag)12/30/2013 Same as last inspection. (DWR Sutter Yard - afreitag)7/29/2013 Same as last inspection. (DWR Sutter Yard - afreitag)12/12/2012 Need to be properly abandoned. Transverse cracks on levee road.Also found a concrete outlet on LS. It is not clear whether this passes through the levee. (DWR UCIP - pamatya) FIELD_STRUCT_DESC: *ABANDONED* 16-inch steel irrigation pipe, 13.9 feet below the crown. Gate valve and pump in pump house on the waterside (WS) berm. 2-3 inch electrical conduit penetrates levee alongside pipe. Flap gate and concrete distribution box on the landside (LS). (Automatic Board Order (ABO) issued as Permit No. 9501, 1974 - Mayfair Farms, abandoned under Permit No. 9501-A, 1978 - MayFair Packing, Inc.). [Additional Reference(s): DWR Levee Log, 2002. USACE Sacramento O&M Manual 136, March 1960 (HLM 4.37)] FS Date: 8/30/2018 11:27:41 AM

Waterside view: overview of pipe

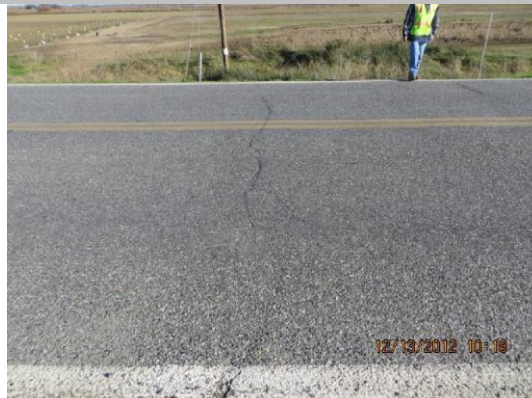
Photo 1 of 3 : UCIP_FA_2018_51676_47087.jpg

Comment Code					
Inspector Comment					
FS_ID:51676 DS_ID:17484 EP_NO: N/A Repair Type: Non-Urgent Crossing Status: Found UCIP Comments: 4/24/2017 Abandoned- needs to be done so properly. WS underwater during site visit. (DWR Sutter Yard- AFreitag)11/7/2016 Abandoned but needs to be done so properly. (DWR Sutter Yard- AFreitag)9/29/2016 Crossing has been downgraded from Urgent to Non-Urgent crossing is abandoned and WS surge box is full of debris. Need to contact owner and have owner coordinate with CVFPB to comply with Title 23. (DWR UCIP - omagana)6/17/2016 Abandoned crossing. Photo comments updated. (DWR Sutter Yard - afreitag)4/4/2016 Same as last inspection. (DWR UCIP - kfazel)4/6/2015 Crossing appears to be an old irrigation structure and not a drain pipe. It appears abandoned as WS surge box is full of debris. (DWR Sutter Yard - afreitag)6/30/2014 Same as last inspection. (DWR Sutter Yard - afreitag)12/30/2013 Same as last inspection. (DWR Sutter Yard - afreitag)7/29/2013 Same as last inspection. (DWR Sutter Yard - afreitag)12/12/2012 Debris and deteriorated concrete. Gate valve in surge tank. (DWR UCIP - pamatya) FIELD_STRUCT_DESC: *ABANDONED* 24-inch steel irrigation pipe through the levee, invert 26 feet below the crown. Slide gate on the waterside (WS). [Additional Reference(s): USACE Sacramento O&M Manual 136, March 1960 (HLM 4.37)]. FS Date: 4/26/2017 12:59:53 PM

Crown view: transverse crack on levee road

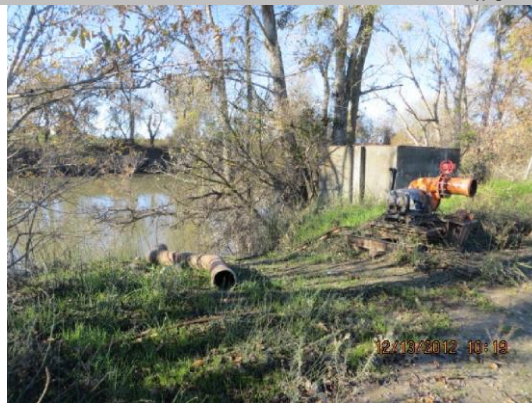
Photo 2 of 3 : UCIP_FA_2018_51676_47086.jpg

Waterside view: overview of concrete surge box

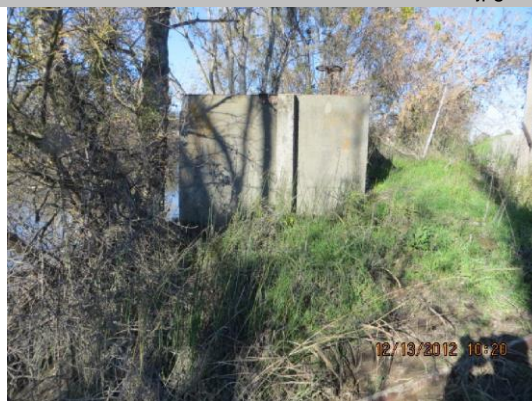
Photo 3 of 3 : UCIP_FA_2018_51676_47085.jpg

Comment Code						
Inspector Comment						
FS_ID:51676 DS_ID:17484 EP_NO: N/A Repair Type: Non-Urgent Crossing Status: Found UCIP Comments: 4/24/2017 Abandoned- needs to be done so properly. WS underwater during site visit. (DWR Sutter Yard- AFreitag)11/7/2016 Abandoned but needs to be done so properly. (DWR Sutter Yard- AFreitag)9/29/2016 Crossing has been downgraded from Urgent to Non-Urgent crossing is abandoned and WS surge box is full of debris. Need to contact owner and have owner coordinate with CVFPB to comply with Title 23. (DWR UCIP - omagana)6/17/2016 Abandoned crossing. Photo comments updated. (DWR Sutter Yard - afreitag)4/4/2016 Same as last inspection. (DWR UCIP - kfazel)4/6/2015 Crossing appears to be an old irrigation structure and not a drain pipe. It appears abandoned as WS surge box is full of debris. (DWR Sutter Yard - afreitag)6/30/2014 Same as last inspection. (DWR Sutter Yard - afreitag)12/30/2013 Same as last inspection. (DWR Sutter Yard - afreitag)7/29/2013 Same as last inspection. (DWR Sutter Yard - afreitag)12/12/2012 Debris and deteriorated concrete. Gate valve in surge tank. (DWR UCIP - pamatya) FIELD_STRUCT_DESC: *ABANDONED* 24-inch steel irrigation pipe through the levee, invert 26 feet below the crown. Slide gate on the waterside (WS). [Additional Reference(s): USACE Sacramento O&M Manual 136, March 1960 (HLM 4.37)]. FS Date: 4/26/2017 12:59:53 PM

Waterside view: concrete surge box

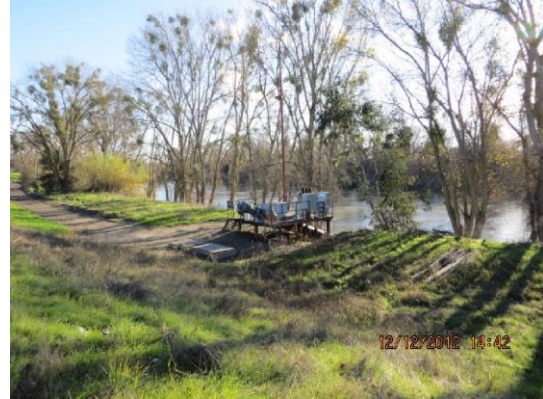
Photo 1 of 3 : UCIP_FA_2018_51677_47092.jpg

Comment Code					
Inspector Comment					
FS_ID:51677 DS_ID:17318 EP_NO: 9501 Repair Type: Non-Urgent Crossing Status: Found UCIP Comments: 4/24/2017 LS shoulder erosion repaired. Not sure if any changes or repairs were done to the pipe itself. (DWR Sutter Yard- AFreitag)11/7/2016 LS erosion still a problem at the LS shoulder. (DWR Sutter Yard- AFreitag)6/6/2016 LS erosion still present and appears to be getting worse. It is only a few inches away from affecting the paved road way. (DWR Sutter Yard - afreitag)4/4/2016 Same as last inspection. Erosion problem is urgently in need of repair. (DWR UCIP - kfazel)4/6/2015 Erosion problem still present near the LS shoulder. If it gets any worse then it may start to affect the road way. Found a siphon breaker on LS. Antenna and pump station on WS. Huge erosion on LS slope. (DWR Sutter Yard - afreitag)6/30/2014 Same as last inspection. (DWR Sutter Yard - afreitag)12/30/2013 Same as last inspection. (DWR Sutter Yard - afreitag)7/29/2013 Erosion near LS shoulder may start affecting the roadway if it gets any worse.12/12/2012 Found a siphon breaker on LS. Antenna and pump station on WS. Huge erosion on LS slope. (DWR UCIP - pamatya) FIELD_STRUCT_DESC: 24-inch asphalt coated steel irrigation pipe, 4 feet below the crown. Slant pump on a steel platform on the waterside (WS) berm. Siphon breaker on the apex of the pipe and off the levee crown on the landside (LS). 2 shut-off (butterfly) valves off the LS toe. Power pole with electrical conduit and panel on the LS toe. Pipe appears to run diagonally through the levee and discharges into a ditch off the LS toe. Gate structure on the outlet at the ditch. (Automatic Board Order (ABO) issued as Permit No. 9501, 1974 - Mayfair Farms, Inc.). Slant pump installed under Permit No. 10935, 1975 - Pires. [Additional Reference(s): DWR Levee Log, 2002]. FS Date: 4/26/2017 1:01:23 PM

Waterside view: overview

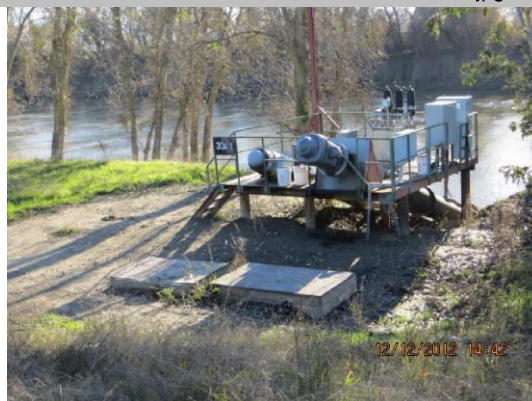
Photo 2 of 3 : UCIP_FA_2018_51677_47091.jpg

UCIP Comments: 4/24/2017 LS shoulder erosion repaired. Not sure if any changes or repairs were done to the pipe itself. (DWR Sutter Yard-AFreitag)11/7/2016 LS erosion still a problem at the LS shoulder.

Waterside view: overview of pump station

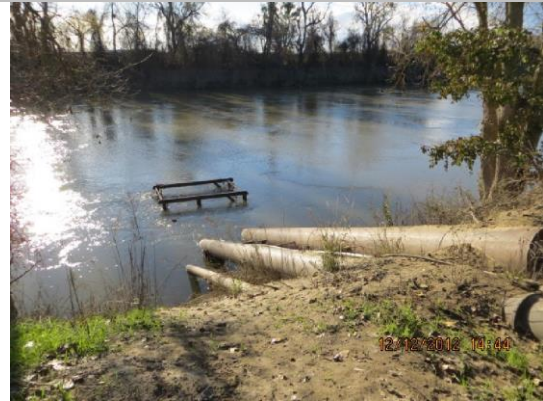
Photo 3 of 3 : UCIP_FA_2018_51677_47096.jpg

Comment Code						
Inspector Comment						
FS_ID:51677 DS_ID:17318 EP_NO: 9501 Repair Type: Non-Urgent Crossing Status: Found UCIP Comments: 4/24/2017 LS shoulder erosion repaired. Not sure if any changes or repairs were done to the pipe itself. (DWR Sutter Yard- AFreitag)11/7/2016 LS erosion still a problem at the LS shoulder. (DWR Sutter Yard- AFreitag)6/6/2016 LS erosion still present and appears to be getting worse. It is only a few inches away from affecting the paved road way. (DWR Sutter Yard - afreitag)4/4/2016 Same as last inspection. Erosion problem is urgently in need of repair. (DWR UCIP - kfazel)4/6/2015 Erosion problem still present near the LS shoulder. If it gets any worse then it may start to affect the road way. Found a siphon breaker on LS. Antenna and pump station on WS. Huge erosion on LS slope. (DWR Sutter Yard - afreitag)6/30/2014 Same as last inspection. (DWR Sutter Yard - afreitag)12/30/2013 Same as last inspection. (DWR Sutter Yard - afreitag)7/29/2013 Erosion near LS shoulder may start affecting the roadway if it gets any worse.12/12/2012 Found a siphon breaker on LS. Antenna and pump station on WS. Huge erosion on LS slope. (DWR UCIP - pamatya) FIELD_STRUCT_DESC: 24-inch asphalt coated steel irrigation pipe, 4 feet below the crown. Slant pump on a steel platform on the waterside (WS) berm. Siphon breaker on the apex of the pipe and off the levee crown on the landside (LS). 2 shut-off (butterfly) valves off the LS toe. Power pole with electrical conduit and panel on the LS toe. Pipe appears to run diagonally through the levee and discharges into a ditch off the LS toe. Gate structure on the outlet at the ditch. (Automatic Board Order (ABO) issued as Permit No. 9501, 1974 - Mayfair Farms, Inc.). Slant pump installed under Permit No. 10935, 1975 - Pires. [Additional Reference(s): DWR Levee Log, 2002]. FS Date: 4/26/2017 1:01:23 PM

Waterside view: inclined pipes

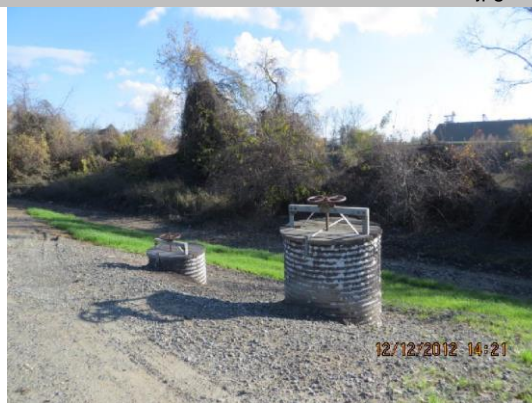
Photo 1 of 3 : UCIP_FA_2018_51679_47107.jpg

Comment Code					
Inspector Comment					
FS_ID:51679 DS_ID:17287 EP_NO: 9520 Repair Type: Non-Urgent Crossing Status: Indicator Found UCIP Comments: 4/24/2017 Abandoned- needs to be done properly. (DWR Sutter Yard- AFreitag)11/7/2016 appears abandoned and should be done so properly. (DWR Sutter Yard- AFreitag)6/6/2016 Appears to be an abandoned crossing.4/6/2015 Same as last inspection. Still appears abandoned. A concrete standpipe and a CMP riser on WS. It seems abandoned and if so should be done so properly.6/30/2014 Same as last inspection.12/30/2013 Same as last inspection.7/29/2013 Same as last inspection. FIELD_STRUCT_DESC: *ABANDONED* 24-inch corrugated metal drainage pipe through the levee, 17 feet below the crown, not found in 2015. Slide gate in a corrugated metal pipe (CMP) riser on the waterside (WS) slope, found in 2015. Pump on the WS bank and concrete standpipe on the WS berm, found in 2015. 18-inch concrete pipe from standpipe at WS toe. Pipe discharges into a field on the landside (LS), not found in 2015. (24-inch pipe [HLM 4.99] authorized under Automatic Board Order (ABO) issued as Permit No. 9520, 1974 - Arnold). [Additional Reference(s): DWR Levee Log, 2002. USACE Sacramento O&M Manual 136, March 1960 (HLM 4.99)]. FS Date: 4/26/2017 1:07:37 PM

Waterside view: overview

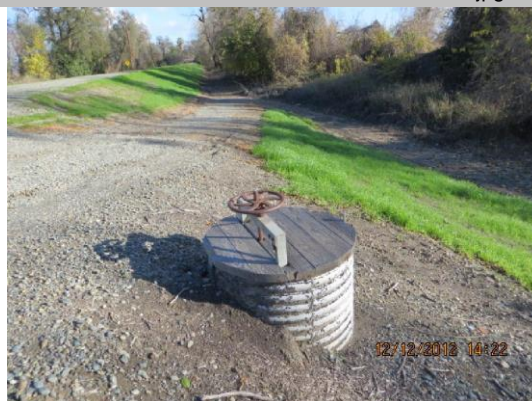
Photo 2 of 3 : UCIP_FA_2018_51679_47106.jpg

FS_ID:51679
DS_ID:17287
EP_NO: 9520
Repair Type: Non-Urgent
Crossing Status: Indicator Found
UCIP Comments: 4/24/2017 Abandoned- needs to be done properly. (DWR Sutter Yard- AFreitag)11/7/2016 appears abandoned and should be done so properly. (DWR Sutter Yard- AFreitag)6/6/2016 Appears to be an abandoned crossing.4/6/2015 Same as last inspection. Still appears abandoned. A concrete standpipe and a CMP riser on WS. It seems abandoned and if so should be done so properly.6/30/2014 Same as last inspection.12/30/2013 Same as last inspection.7/29/2013 Same as last inspection.
FIELD_STRUCT_DESC: *ABANDONED* 24-inch corrugated metal drainage pipe through the levee, 17 feet below the crown, not found in 2015. Slide gate in a corrugated metal pipe (CMP) riser on the waterside (WS) slope, found in 2015. Pump on the WS bank and concrete standpipe on the WS berm, found in 2015. 18-inch concrete pipe from standpipe at WS toe. Pipe discharges into a field on the landside (LS), not found in 2015. (24-inch pipe [HLM 4.99] authorized under Automatic Board Order (ABO) issued as Permit No. 9520, 1974 - Arnold). [Additional Reference(s): DWR Levee Log, 2002. USACE Sacramento O&M Manual 136, March 1960 (HLM 4.99)].

Waterside view: CMP riser with slide gate

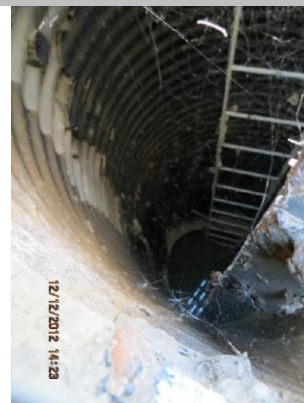
Photo 3 of 3 : UCIP_FA_2018_51679_47105.jpg

Waterside view: inside CMP riser

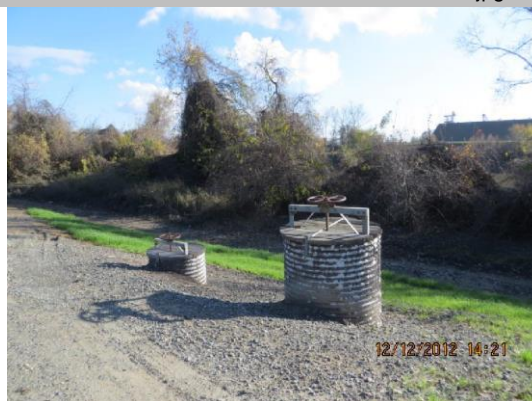
Photo 1 of 3 : UCIP_FA_2018_51680_47112.jpg

Comment Code					
Inspector Comment					
FS_ID:51680 DS_ID:17288 EP_NO: N/A Repair Type: Non-Urgent Crossing Status: Indicator Found UCIP Comments: 4/24/2017 Abandoned- needs to be done so properly. (DWR Sutter Yard- AFreitag)11/7/2016 Appears abandoned, Should be done so properly. (DWR Sutter Yard- AFreitag)6/6/2016 Appears to be an abandoned crossing.4/4/2016 If abandoned, should be done so properly.4/6/2015 Same as last inspection. Only WS riser amd slide gate found.Only a CMP riser with slide gate found on WS.6/30/2014 Same as last inspection.12/30/2013 Same as last inspection.7/29/2013 Same as last inspection. FIELD_STRUCT_DESC: *ABANDONED* 36-inch corrugated metal drainage pipe through the levee, 13.8 feet below the crown, not found in 2015. Slide gate in a CMP riser on the waterside (WS) slope, found in 2015. Flap gate removed at the landside (LS) end. (Automatic Board Order (ABO) issued as Permit No. 9520, 1974 - Arnold). [Additional Reference(s): DWR Levee Log, 2002. USACE Sacramento O&M Manual 136, March 1960 (HLM 4.99)]. FS Date: 4/26/2017 1:19:25 PM

Waterside view: CMP riser with slide gate (right)

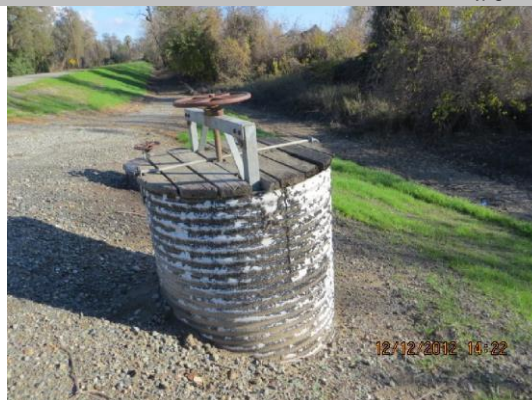
Photo 2 of 3 : UCIP_FA_2018_51680_47111.jpg

Waterside view: CMP riser with slide gate

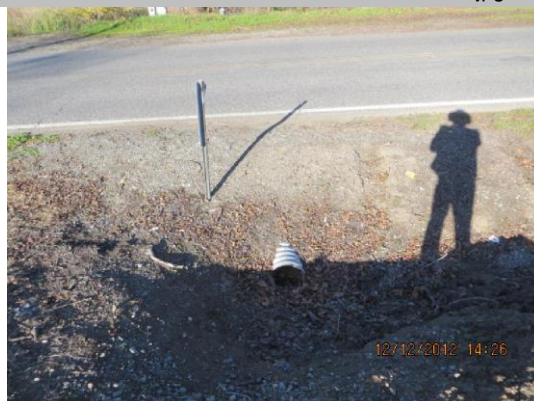
Photo 3 of 3 : UCIP_FA_2018_51680_47110.jpg

Comment Code						
Inspector Comment						
FS_ID:51680 DS_ID:17288 EP_NO: N/A Repair Type: Non-Urgent Crossing Status: Indicator Found UCIP Comments: 4/24/2017 Abandoned- needs to be done so properly. (DWR Sutter Yard- AFreitag)11/7/2016 Appears abandoned, Should be done so properly. (DWR Sutter Yard- AFreitag)6/6/2016 Appears to be an abandoned crossing.4/4/2016 If abandoned, should be done so properly.4/6/2015 Same as last inspection. Only WS riser amd slide gate found.Only a CMP riser with slide gate found on WS.6/30/2014 Same as last inspection.12/30/2013 Same as last inspection.7/29/2013 Same as last inspection. FIELD_STRUCT_DESC: *ABANDONED* 36-inch corrugated metal drainage pipe through the levee, 13.8 feet below the crown, not found in 2015. Slide gate in a CMP riser on the waterside (WS) slope, found in 2015. Flap gate removed at the landside (LS) end. (Automatic Board Order (ABO) issued as Permit No. 9520, 1974 - Arnold). [Additional Reference(s): DWR Levee Log, 2002. USACE Sacramento O&M Manual 136, March 1960 (HLM 4.99)]. FS Date: 4/26/2017 1:19:25 PM

Landside view: overview- county road and road drainpipe

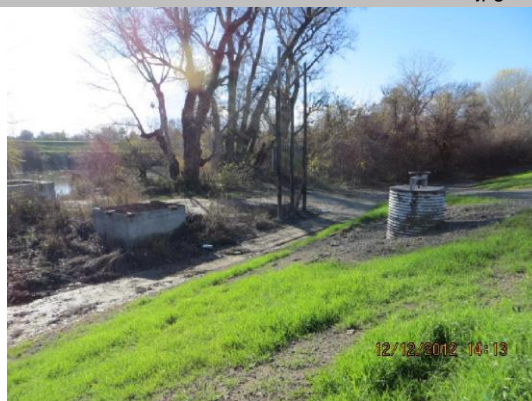
Photo 1 of 3 : UCIP_FA_2018_51681_47115.jpg

FS_ID:51681
DS_ID:17289
EP_NO: N/A
Repair Type: Non-Urgent
Crossing Status: Found
UCIP Comments: 4/24/2017 Appears abandoned- needs to be done so properly. Sloughing still present near WS surge box. (DWR Sutter Yard- A Freitag)11/7/2016 Appears abandoned but needs to be done so properly. (DWR Sutter Yard- A Freitag)6/6/2016 Sink holes appear to have been repaired but there is still some minor sloughing around the WS surge box. Surge box was full of water at time of inspection and I could not see the pipe inside to see if it still looked corroded and rusty.4/4/2016 Could not find sink holes as in 07/2013 photo. Appears repaired, but sloughing still present around surge box. Need confirmation that pipe was abandoned properly.4/6/2015 Repairs are in progress to this crossing. Surge box on WS and distribution box across the county road on LS. Abandoned pump station and electrical panel on WS. A concrete pump pit on WS.6/30/2014 Sink hole near WS surge box is still present. Portable pumps were lowered down the WS bank and were pumping water directly into WS standpipe on to by pass the surge box.12/30/2013 Sink Hole above pipe on WS still present. Pipe end inside of WS surge box shows heavy signs of rust and corrosion. Recommend having an internal camera inspection completed on pipe.7/29/2013 Portable tow-pump lowered down WS berm to water level and is pumping water into concrete surge box on WS and the filling the irrigation ditch on LS. Sink hole with standing water that is present above the outlet pipe for the WS surge box. This may indicate a leaking pipe or cracked concrete.

Waterside view: overview

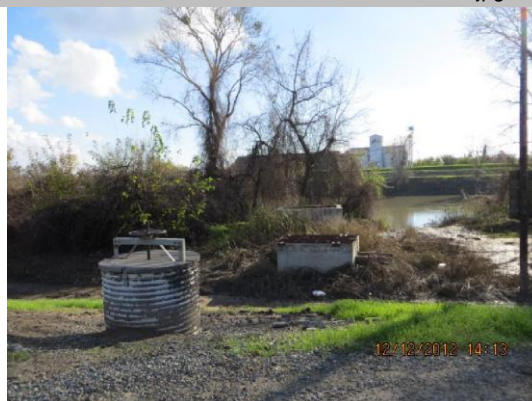
Photo 2 of 3 : UCIP_FA_2018_51681_47113.jpg

FS_ID:51681
DS_ID:17289
EP_NO: N/A
Repair Type: Non-Urgent
Crossing Status: Found
UCIP Comments: 4/24/2017 Appears abandoned- needs to be done so properly. Sloughing still present near WS surge box. (DWR Sutter Yard- A Freitag)11/7/2016 Appears abandoned but needs to be done so properly. (DWR Sutter Yard- A Freitag)6/6/2016 Sink holes appear to have been repaired but there is still some minor sloughing around the WS surge box. Surge box was full of water at time of inspection and I could not see the pipe inside to see if it still looked corroded and rusty.4/4/2016 Could not find sink holes as in 07/2013 photo. Appears repaired, but sloughing still present around surge box. Need confirmation that pipe was abandoned properly.4/6/2015 Repairs are in progress to this crossing. Surge box on WS and distribution box across the county road on LS. Abandoned pump station and electrical panel on WS. A concrete pump pit on WS.6/30/2014 Sink hole near WS surge box is still present. Portable pumps were lowered down the WS bank and were pumping water directly into WS standpipe on to by pass the surge box.12/30/2013 Sink Hole above pipe on WS still present. Pipe end inside of WS surge box shows heavy signs of rust and corrosion. Recommend having an internal camera inspection completed on pipe.7/29/2013 Portable tow-pump lowered down WS berm to water level and is pumping water into concrete surge box on WS and the filling the irrigation ditch on LS. Sink hole with standing water that is present above the outlet pipe for the WS surge box. This may indicate a leaking pipe or cracked concrete.

Waterside view: CMP riser and surge box

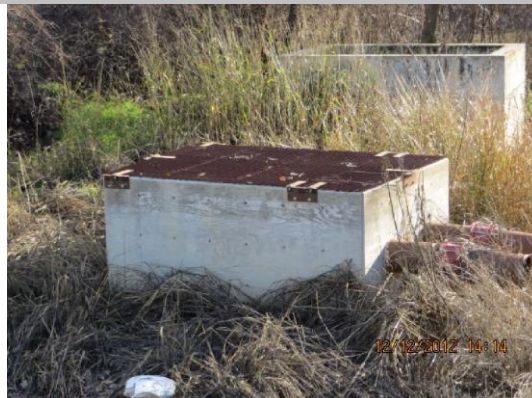
Photo 3 of 3 : UCIP_FA_2018_51681_47114.jpg

FS_ID:51681
DS_ID:17289
EP_NO: N/A
Repair Type: Non-Urgent
Crossing Status: Found
UCIP Comments: 4/24/2017 Appears abandoned- needs to be done so properly. Sloughing still present near WS surge box. (DWR Sutter Yard- A Freitag)11/7/2016 Appears abandoned but needs to be done so properly. (DWR Sutter Yard- A Freitag)6/6/2016 Sink holes appear to have been repaired but there is still some minor sloughing around the WS surge box. Surge box was full of water at time of inspection and I could not see the pipe inside to see if it still looked corroded and rusty.4/4/2016 Could not find sink holes as in 07/2013 photo. Appears repaired, but sloughing still present around surge box. Need confirmation that pipe was abandoned properly.4/6/2015 Repairs are in progress to this crossing. Surge box on WS and distribution box across the county road on LS. Abandoned pump station and electrical panel on WS. A concrete pump pit on WS.6/30/2014 Sink hole near WS surge box is still present. Portable pumps were lowered down the WS bank and were pumping water directly into WS standpipe on to by pass the surge box.12/30/2013 Sink Hole above pipe on WS still present. Pipe end inside of WS surge box shows heavy signs of rust and corrosion. Recommend having an internal camera inspection completed on pipe.7/29/2013 Portable tow-pump lowered down WS berm to water level and is pumping water into concrete surge box on WS and the filling the irrigation ditch on LS. Sink hole with standing water that is present above the outlet pipe for the WS surge box. This may indicate a leaking pipe or cracked concrete.

Waterside view: closer look at surge box

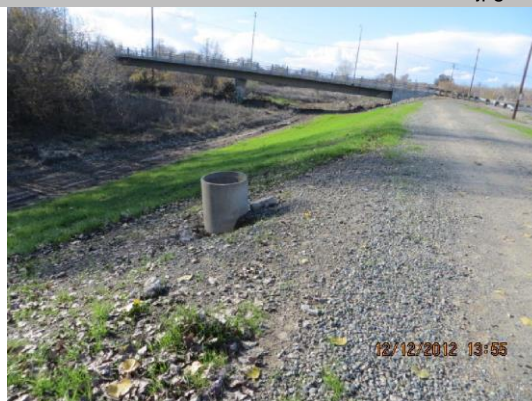
Photo 1 of 3 : UCIP_FA_2018_51683_47127.jpg

Comment Code					
Inspector Comment					
FS_ID:51683 DS_ID:17291 EP_NO: 4091 Repair Type: Non-Urgent Crossing Status: Found UCIP Comments: 4/24/2017 Abandoned- needs to be done properly. (DWR Sutter Yard- AFreitag)11/7/2016 Abandoned and should be done so properly. (DWR Sutter Yard- AFreitag)6/6/2016 Appears to be an abandoned crossing. WS was to over grown with vegetation to access the area where the WS pump structure was previously found.4/6/2015 Same as last inspection. Crossing appears abandoned. Appears abandoned and if so should be done so properly. No Siphon breaker found on LS.6/30/2014 Same as last inspection.12/30/2013 Same as last inspection.7/29/2013 Same as last inspection. FIELD_STRUCT_DESC: *ABANDONED* 8-inch asphalt coated steel irrigation pipe through the levee, 4 feet below the crown. Pump on the waterside (WS) bank. Gate valve in a concrete pipe riser on the WS shoulder. (Permit No. 4091, 1962 - Halsey, Yerxa). [Additional Reference(s): DWR Levee Log, 2002]. FS Date: 4/26/2017 1:30:30 PM

Waterside view: concrete pipe riser with gate valve

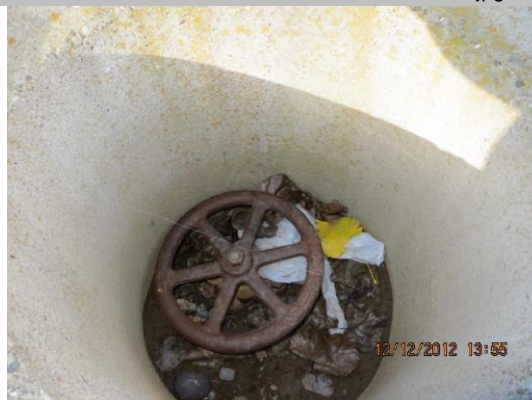
Photo 2 of 3 : UCIP_FA_2018_51683_47126.jpg

Waterside view: burried gate valve in concrete pipe riser

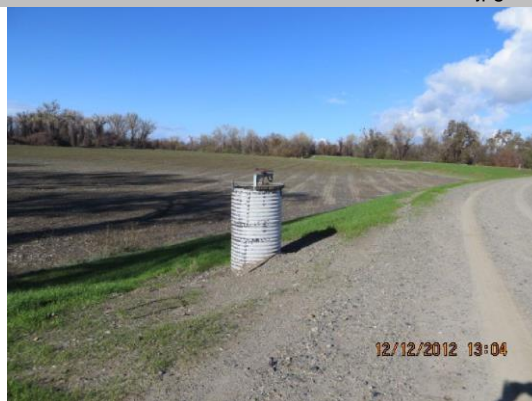
Photo 1 of 3 : UCIP_FA_2018_51688_47158.jpg

Comment Code						
Inspector Comment						
FS_ID:51688 DS_ID:17306 EP_NO: 9530 Repair Type: Non-Urgent Crossing Status: Found UCIP Comments: 4/16/2017 Abandoned- needs to be done properly. (DWR Sutter Yard- AFreitag)10/31/2016 Appears abandoned. (DWR Sutter Yard- AFreitag)6/1/2016 Appears to be an abandoned crossing. WS end is about 90% buried with soil and the LS end is still unknown.4/1/2015 WS pipe end 3/4 blocked by soil. LS end is still unknown.Pipe outlet on WS partially burried, it needs cleaning.6/30/2014 Same as last inspection.12/18/2013 Same as last inspection.7/23/2013 Same as last inspection FIELD_STRUCT_DESC: *ABANDONED* 30-inch corrugated metal drainage pipe through the levee, 15 feet below the crown. Slide gate in a corrugated metal pipe (CMP) riser on the waterside (WS) slope. (30- inch pipe [HLM 6.37] authorized under Automatic Board Order (ABO) issued as Permit No. 9530, 1974 - Halsey). [Additional Reference(s): DWR Levee Log, 2002]. FS Date: 4/26/2017 1:45:14 PM

Waterside view: CMP riser with slide gate

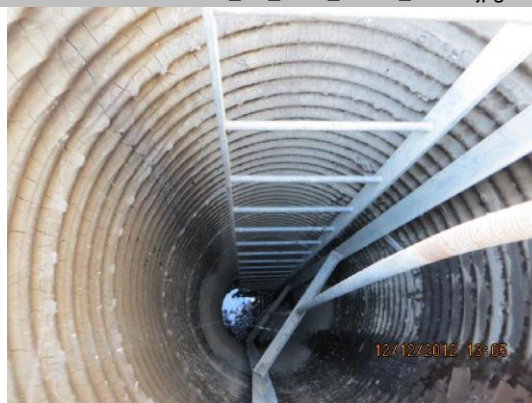
Photo 2 of 3 : UCIP_FA_2018_51688_47156.jpg

Waterside view: inside CMP riser

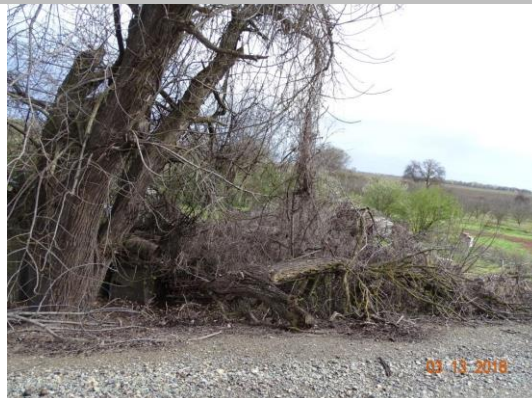
Photo 1 of 1 : FA_2018_ST0003_264_106_20180905_00025.jpg

View of the downed tree along the landside slope.

LM Start	6.47	Rating **	M	Issue No.	106
LM End	6.47	Issue Type +	Ma	Location *	LS
Category	Earthen Levee			GPS Latitude/Longitude	
				Start	End
Item	Encroachments			39.224812 °	39.224812 °
				-121.998615 °	-121.998615 °
DWR ID	DWR_ST0003_01_s_2018_106				
Comment Code					
TR : Tree or limb					
Inspector Comment					
Remove the down tree from the landside slope.

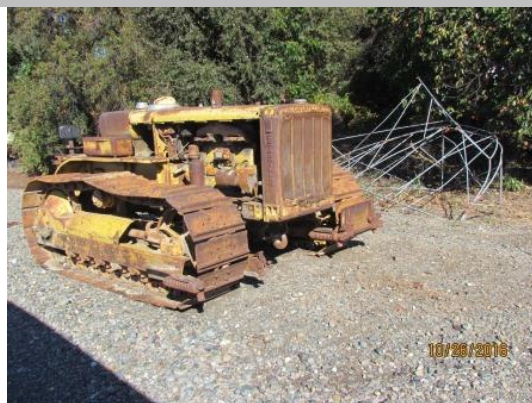
Photo 1 of 1 : FA_2018_ST0003_264_98_20180905_00021.jpg

LM Start	6.51	Rating **	M	Issue No.	98
LM End	6.51	Issue Type +	En	Location *	LS
Category	Earthen Levee			GPS Latitude/Longitude	
				Start	End
Item	Encroachments			39.225307°	39.225307°
				-121.998755°	-121.998755°
DWR ID	DWR_ST0003_01_f_2016_98				
Comment Code					
EQ : Equipment					
Inspector Comment

View of the ag equipment along the landside toe.

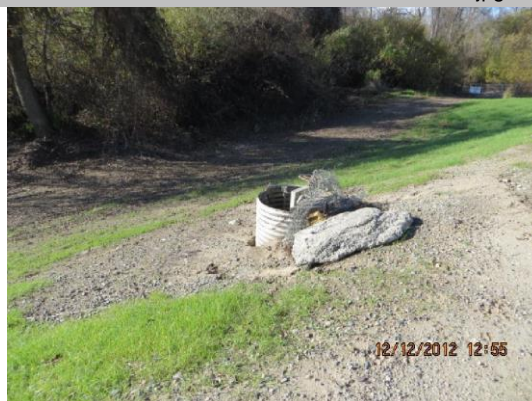
Photo 1 of 2 : UCIP_FA_2018_51689_47181.jpg

FS_ID:51689
DS_ID:17296
EP_NO: 9530
Repair Type: Non-Urgent
Crossing Status: Indicator Found
UCIP Comments: 4/19/2017 Abandoned- needs to be done properly. (DWR Sutter Yard- A Freitag) 10/31/2016 Abandoned. (DWR Sutter Yard- A Freitag) 6/1/2016 Abandoned- only WS riser and screwgate found. 4/1/2015 Only cmp riser with screwgate found on WS. Screwgate stem is bent. Appears abandoned and should be verified as having been done so properly. Only CMP riser with slide gate found on WS 6/30/2014 Same as last inspection. 12/18/2013 Same as last inspection. 7/23/2013 Same as last inspection
FIELD_STRUCT_DESC: *ABANDONED* 24-inch corrugated metal drainage pipe through the levee, 13.5 feet below the crown, not found in 2015. Slide gate in a corrugated metal pipe (CMP) riser on the waterside (WS) slope, found in 2015. (24-inch pipe [HLM 6.61] authorized under Automatic Board Order (ABO) issued as Permit No. 9530, 1974 - Halsey). [Additional Reference(s): DWR Levee Log, 2002. USACE Sacramento O&M Manual 136, March 1960 (HLM 6.61)].

Waterside view: CMP riser with slide gate
